# Testing of New Bridge Rail and Transition Designs

Volume XIII: Appendix L

32-in (813-mm) Thrie-Beam Transition

PUBLICATION NO. FHWA-RD-93-156

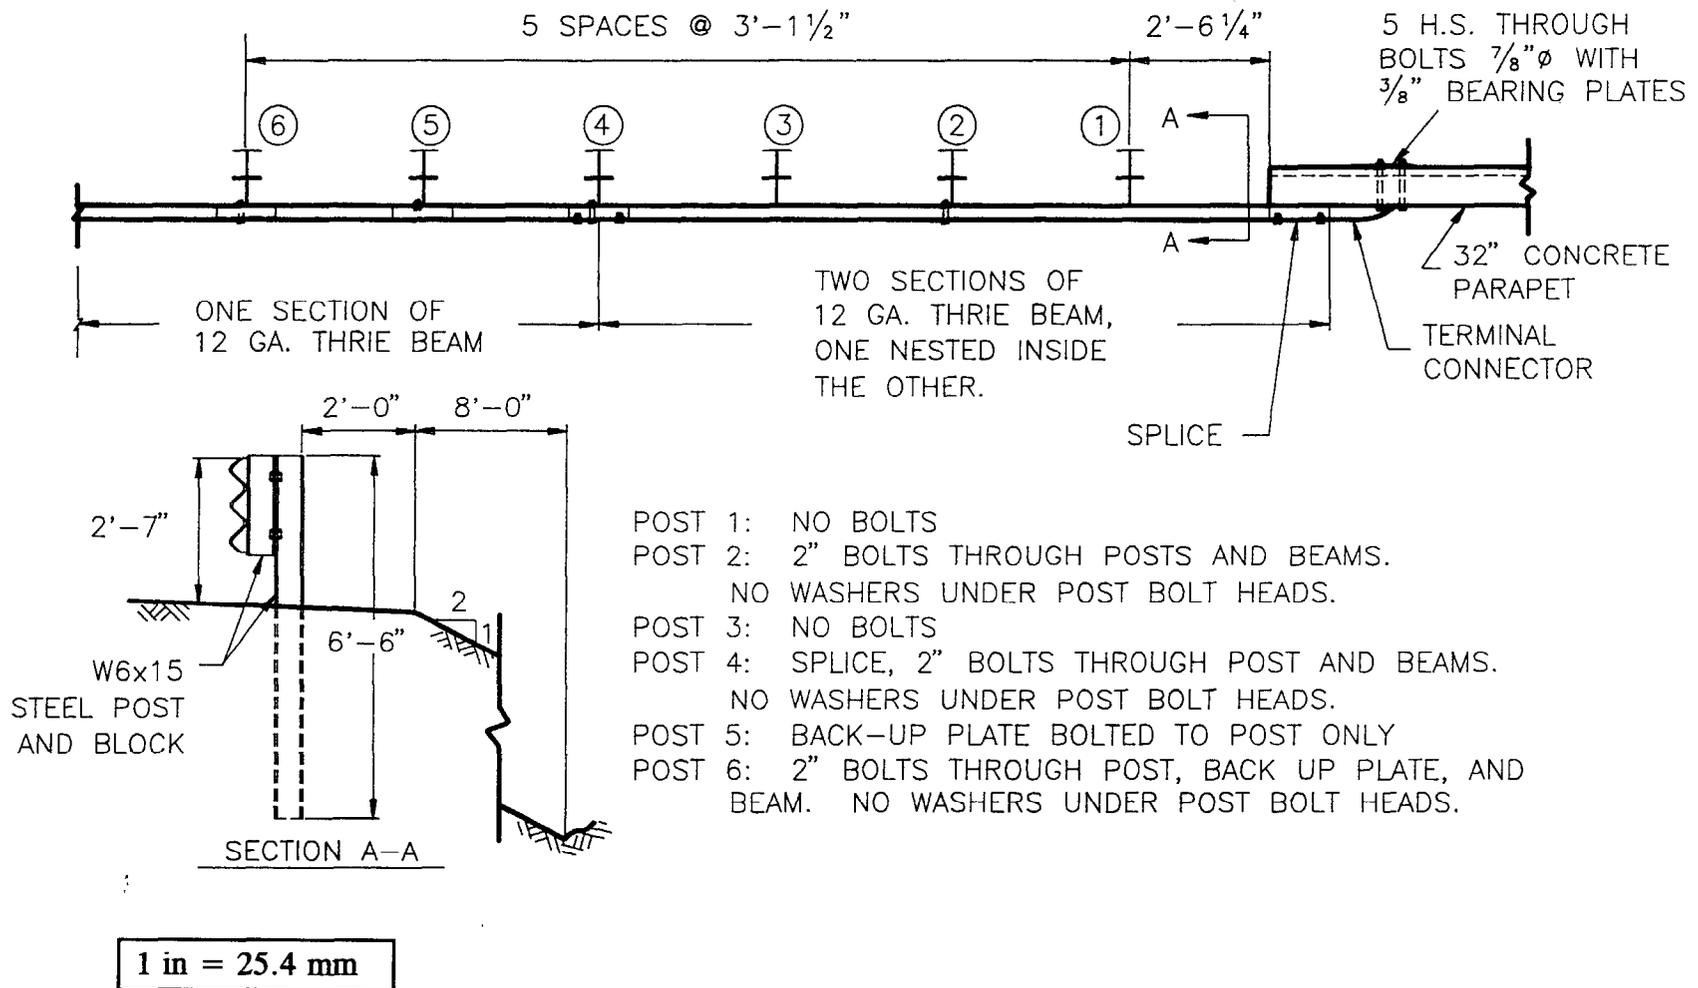
Figure 1. 32-in (813-mm) thrie-beam transition.

An elevation view and cross section of the transition are shown in figure 1. Height to the top of the transition rail element from ground level is 31 in (790 mm). The transition is composed of one section of 12-gauge thrie-beam spliced into two sections of 12-gauge thrie-beam, one nested inside the other. The nested thrie-beams are bolted to a 32-in (813-mm) concrete parapet using the terminal connector shown in figure 2. In tests 7069-19 and 20, a standard thrie-beam terminal connector was used. In test 7069-21, a 12-gauge terminal connector with slanted splice slots was used. In test 7069-29, a 10-gauge terminal connector with slanted splice slots was used. The transition is supported by W6x15 posts and blocks spaced at 3-ft 1-1/2-in (1 m) center-to-center with a 2-ft 6-1/4-in (768 mm) space adjacent to the end of the concrete parapet.

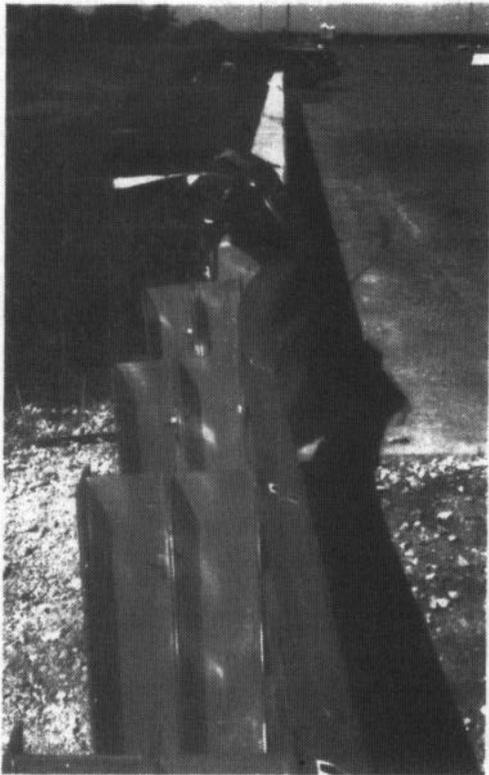
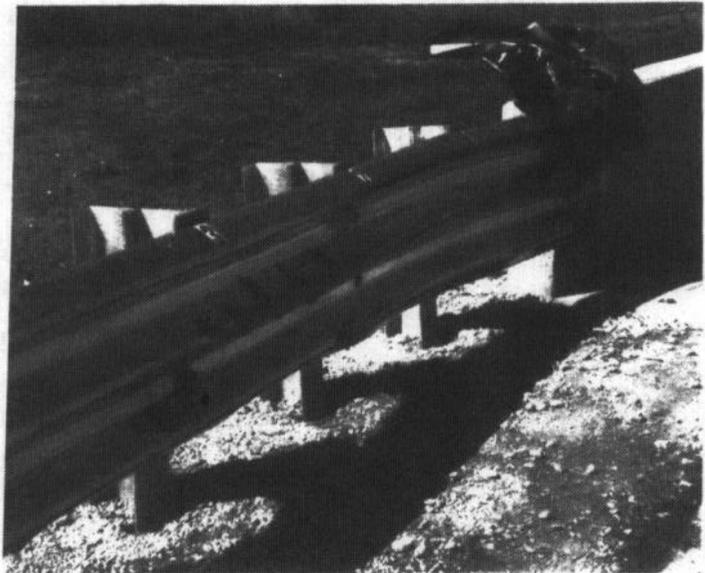
Figure 20. Thrie-beam transition after test 7069-20.

As can be seen in figure 20, the transition received moderate damage. Maximum lateral deformation was 6.5 in (165 mm). The vehicle was in contact with the transition for 8.5 ft (2.6 m).

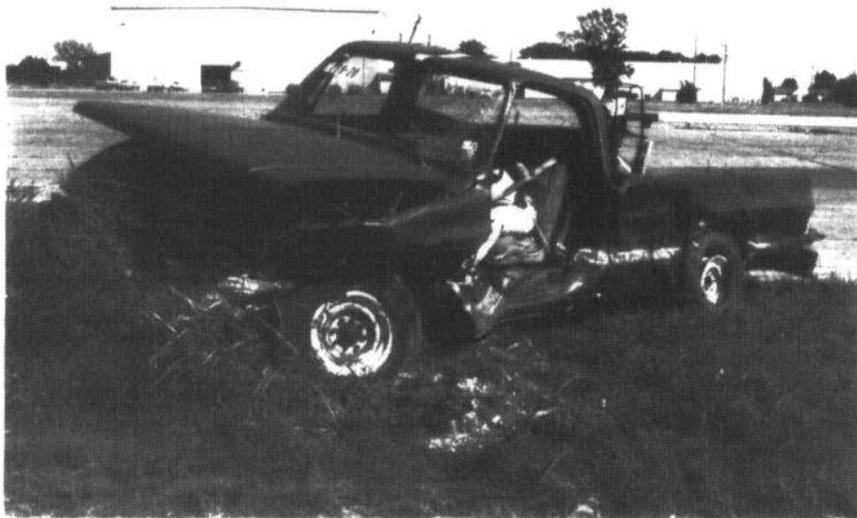
Figure 21. Vehicle after test 7069-20.

The vehicle sustained damage to the left side as shown in figures 21 and 22. Maximum crush at the left front corner at bumper height was 22.0 in (559 mm). The sway bar and upper and lower control arm, the left side were damaged and the roof was bent. The left front wheel was canted inward at the bottom and pushed back into the fender well. The left side window was broken out and the door was off. Also, damage was done to the front bumper, hood, grill, radiator and fan, left front quarter panel, left rear quarter panel, and left rear tire and rim.

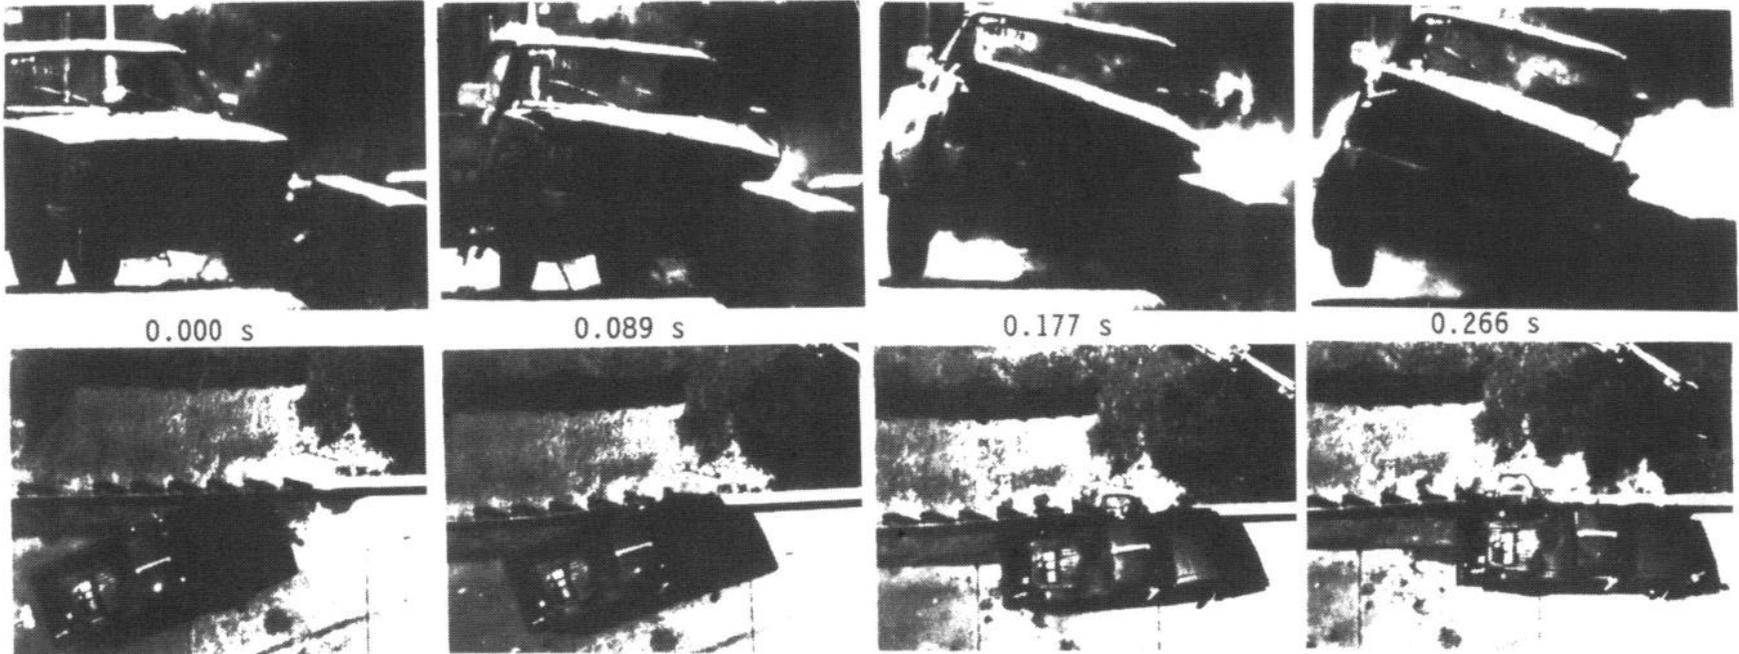
Test No. . . . . 7069-20  
 Date . . . . . 10/19/90  
 Test Installation . . . 32-in (813-mm) Thrie-  
 Beam Transition  
 Installation Length . . 85 ft (26 m)  
 Test Vehicle . . . . . 1981 Chevrolet  
 C-20 Pickup  
 Vehicle Weight  
 Test Inertia . . . . . 5,400 lb (2,452 kg)  
 Gross Static . . . . . 5,570 lb (2,529 kg)  
 Vehicle Damage Classification  
 TAD . . . . . 11FL5 & 11LD7  
 CDC . . . . . 11FLEK3 & 11LDEW3  
 Maximum Vehicle Crush . 22.0 in (559 mm)

CRITERIA		TEST RESULTS		PASS/FAIL*
A.	Must contain vehicle	Vehicle was contained		Pass
B.	Debris shall not penetrate passenger compartment	No debris penetrated passenger compartment		Pass

C.	Passenger compartment must have essentially no deformation	Moderate deformation Door detached		Fail
D.	Vehicle must remain upright	Vehicle did remain upright		Pass

E.	Must smoothly redirect the vehicle	Vehicle was smoothly redirected		Pass
F.	Effective coefficient of friction	<u>μ</u>	<u>Assessment</u>	
		0 - .25	Good	
		.26 - .35	Fair	
		> .35	Marginal	
		.61	Marginal	Fail

H.	Exit angle shall be less than 12 degrees	Exit angle was 6.9 degrees		Pass

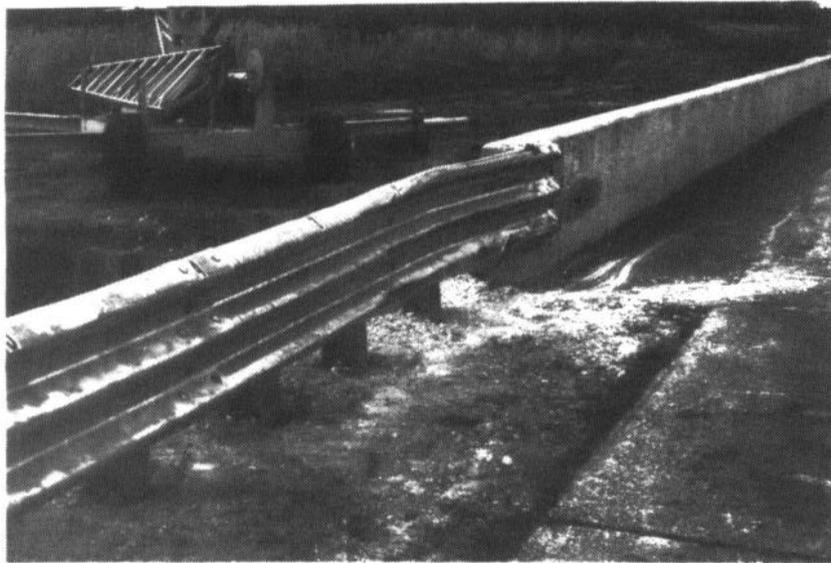
Figure 40. 32-in (813-mm) thrie-beam transition after test 7069-21.

As can be seen in figure 40, the transition received moderate damage. Maximum lateral permanent deformation was 5.0 in (127 mm). The vehicle was in contact with the transition for 14.0 ft (4.2 m).

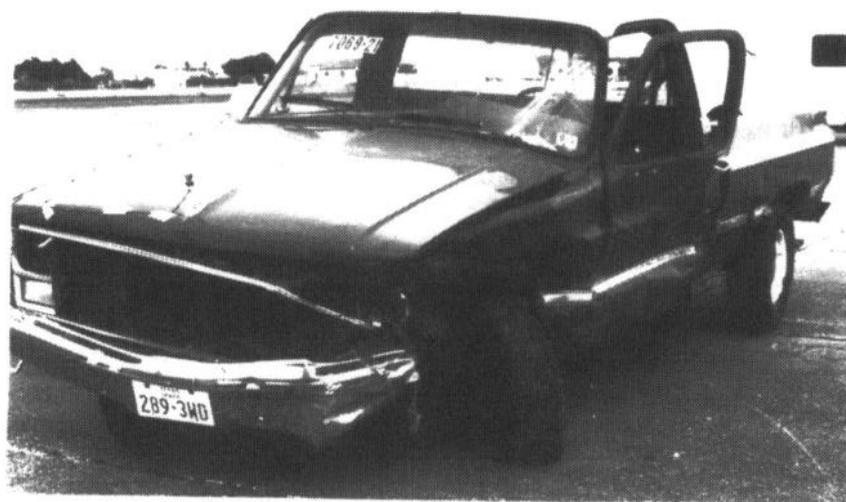
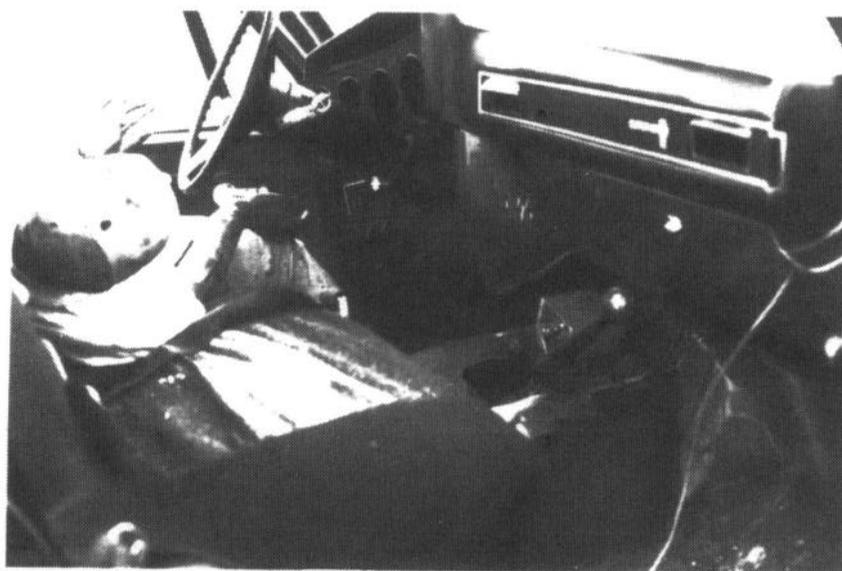
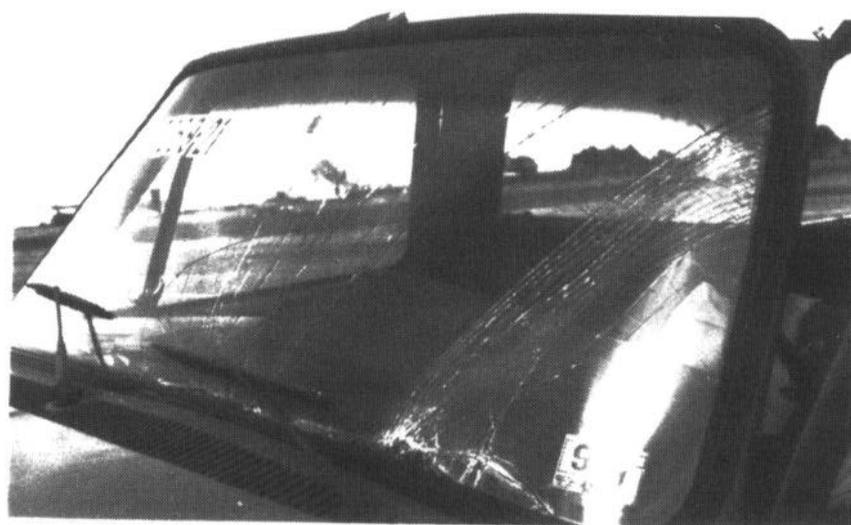
Figure 41. Vehicle after test 7069-21.

The vehicle sustained damage to the left side as shown in figure 41. Maximum crush at the left front corner at bumper height was 15.0 in (381 mm) and the right front corner was deformed outward approximately 4.75 in (121 mm). The sway bar, A-arms on the left side and gas tank were damaged and the drive shaft, frame, and roof was bent. The floorpan was pushed into the occupant compartment approximately 5 to 7 in (130 to 180 mm) and the dash moved inward approximately 3 in (80 mm). The left front wheel was canted inward at the bottom and pushed back into the fender well reducing the wheelbase on the driver side by 14.0 in (356 mm). The driver side window was broken out and the door was jammed. Also, damage was done to the front bumper, hood, grill, radiator and fan, left front quarter panel, left rear quarter panel, and left rear tire and rim. The tailgate came off the vehicle during the test.

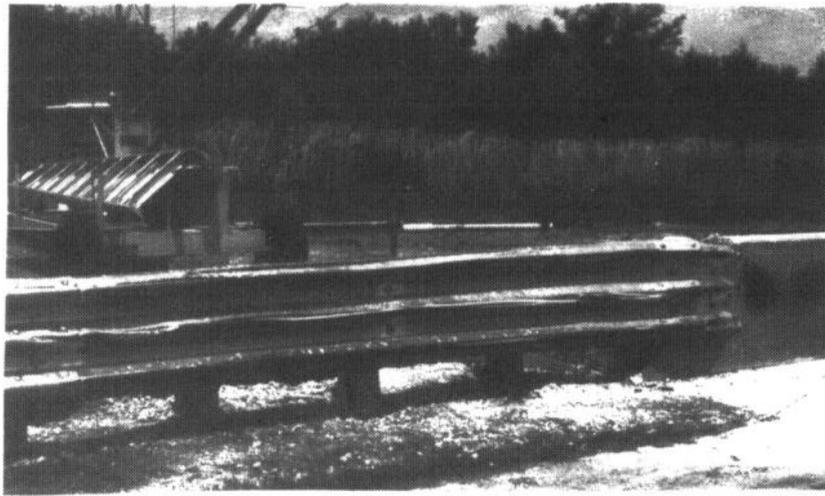
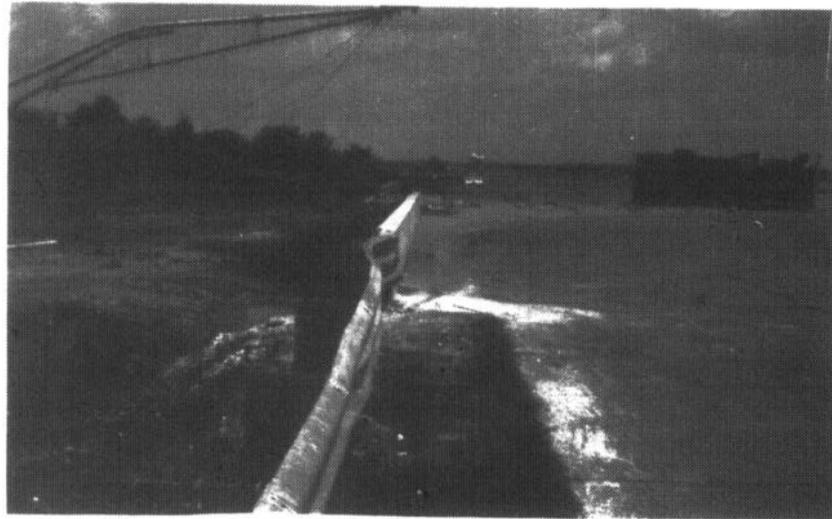
Figure 57. 32-in (813-mm) thrie beam transition after test 7069-29.

As can be seen in figure 57, the transition received moderate damage. Maximum lateral permanent deformation to the transition was 10.0 in (254 mm). The end of the concrete parapet where the terminal connector attached was cracked as shown in figure 58. Damage to the terminal connector is shown in figure 59. The vehicle was in contact with the transition installation for 18.5 ft (5.6 m).

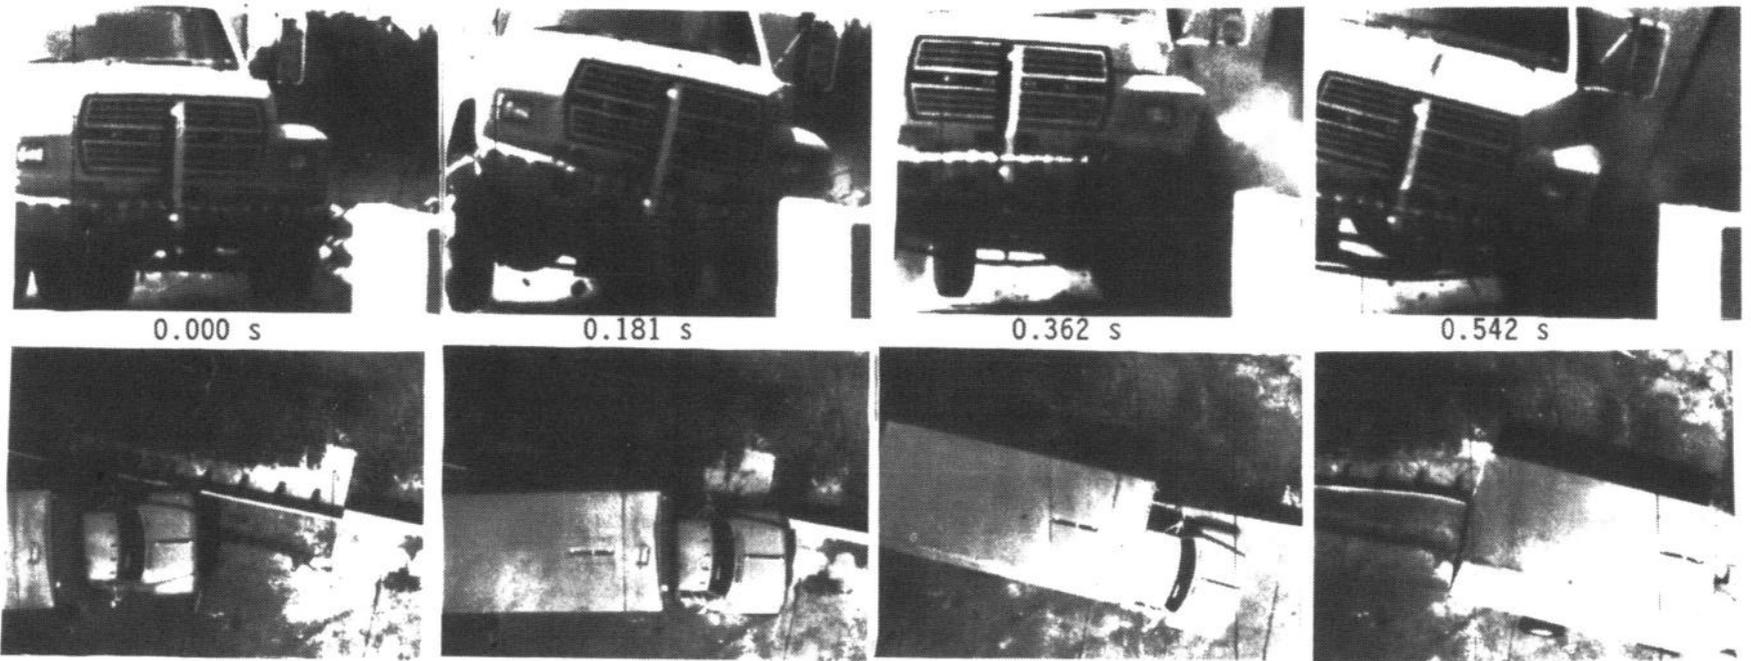
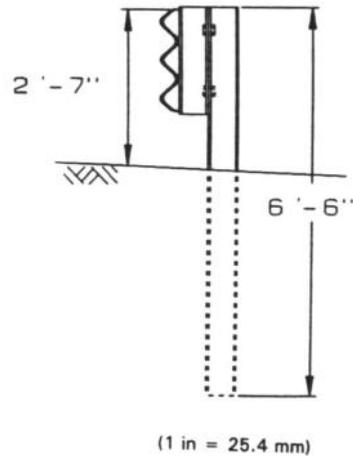
Figure 61. Summary of results for test 7069-29.

Test No. . . . .	7069-29	Impact Speed. . . .	51.6 mi/h (83.0 km/h)
Date . . . . .	06/05/92	Impact Angle. . . .	14.6 deg
Test Installation . . . .	32-in (813-mm) Thrie-Beam Transition	Speed at Parallel . . . .	48.9 mi/h (78.7 km/h)
Installation Length . . . .	85 ft (26 m)	Exit Speed . . . .	N/A
Test Vehicle . . . . .	1981 Ford Single-Unit Truck	Exit Trajectory . . . .	11 deg
Vehicle Weight		Vehicle Accelerations	
Empty Weight . . . . .	10,790 lb (4,899 kg)	(Max. 0.050-sec Avg) at c.g.	
Test Inertia . . . . .	18,000 lb (8,172 kg)	Longitudinal. . . .	-2.3 g
Maximum Vehicle Crush . . . .	13.0 in (330-mm)	Lateral . . . . .	6.3 g
Max. Perm. Deform. . . . .	10.0 in (254 mm)	Occupant Impact Velocity at true c.g.	
		Longitudinal. . . .	9.4 ft/s (2.9 m/s)
		Lateral . . . . .	11.9 ft/s (3.6 m/s)
		Occupant Ridedown Accelerations	
		Longitudinal. . . .	-4.1 g
		Lateral . . . . .	9.0 g
